Dive Report

K Class Submarine

Firth of Forth
June 2007

Written by Andrew Jackson BSc CEng M.I.C.E.

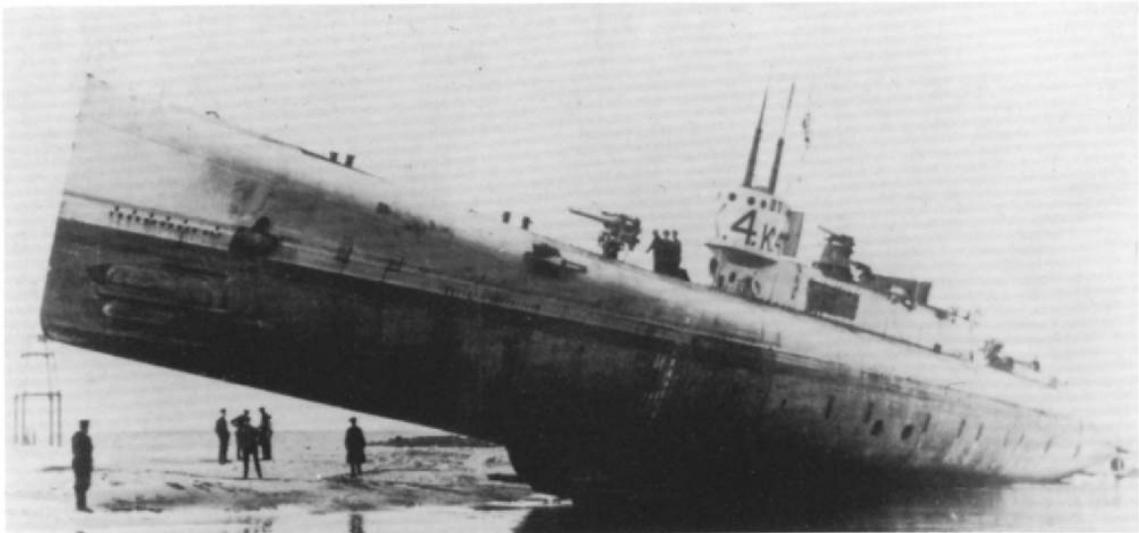
- 9.5. The photograph on the cover shows HMS K4 aground and it is possible that the bow section could have been weakened in previous accidents that were apparently common. Such a failure would have started with tension forces on the upper most part of the hull caused by the stern section tilting backwards whilst the bow was lifting.

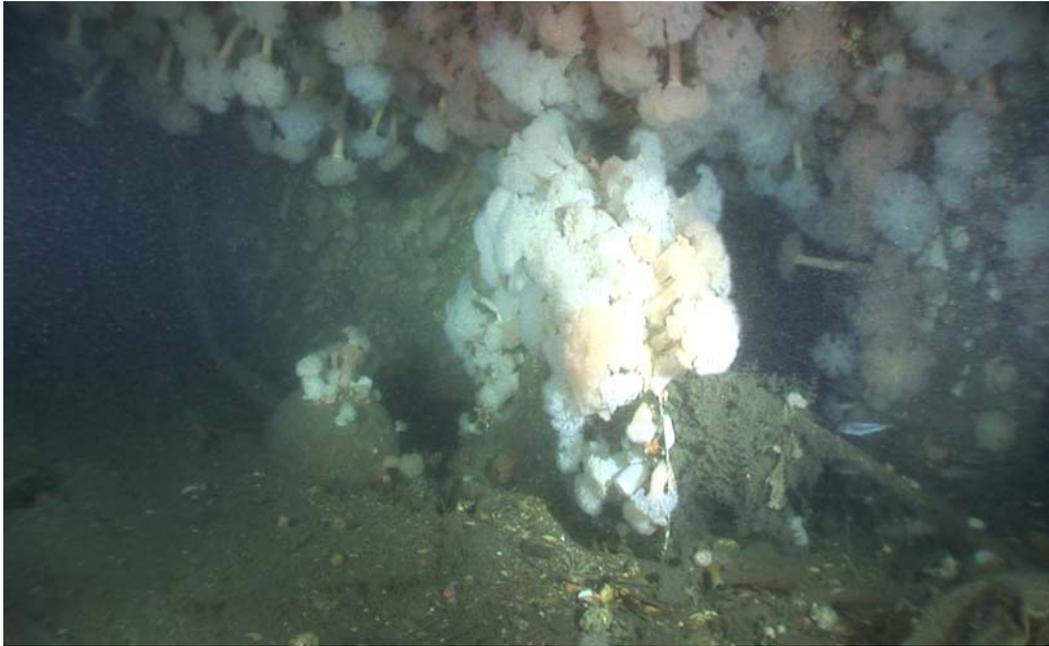
2.1. The view above is of the Starboard propeller with the forward section of the hull to the right. The propeller appears to be pitched the wrong way. Only one blade is visible and the thin vertical line just right of photo centre is the edge of the propeller. Above this the blade is obscured by anemones. The propeller is buried to a point just above the shaft which gives a good indication of silt level at this point on the wreck. The port propeller was not visited.

- 9.1. The wreck is generally sitting above a hard seabed that has a shallow covering of softer material. The only exception to this is at the stern where there appears to be a mound of material pushed back behind the stern. This would strongly suggest that the stern hit the seabed first and the wreckage was not only falling downwards but was also travelling slightly backwards. This also explains the reason for the unusual orientation of the starboard propeller blade.

- 10.2. I would like to film the port propeller and take a closer look at how the stern section is sitting on the seabed. It would also be useful to clean off some of the growth around the starboard side propeller and take a closer look at its orientation.

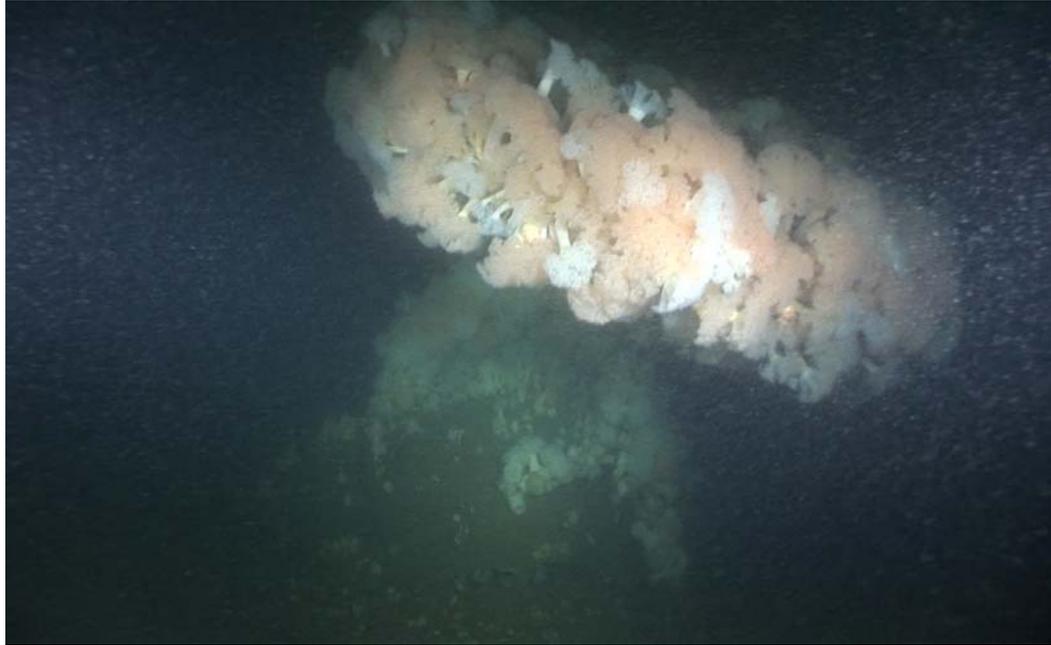
2.2. The view above shows the overhang of the stern and gives a good impression of how the wreck is sitting on the seabed with the starboard side lowest and the deck leaning over to starboard at approximately 20 degrees. The seabed can be seen to be rising up locally around the lower aft end of the wreck around the rudder position which is obscured.

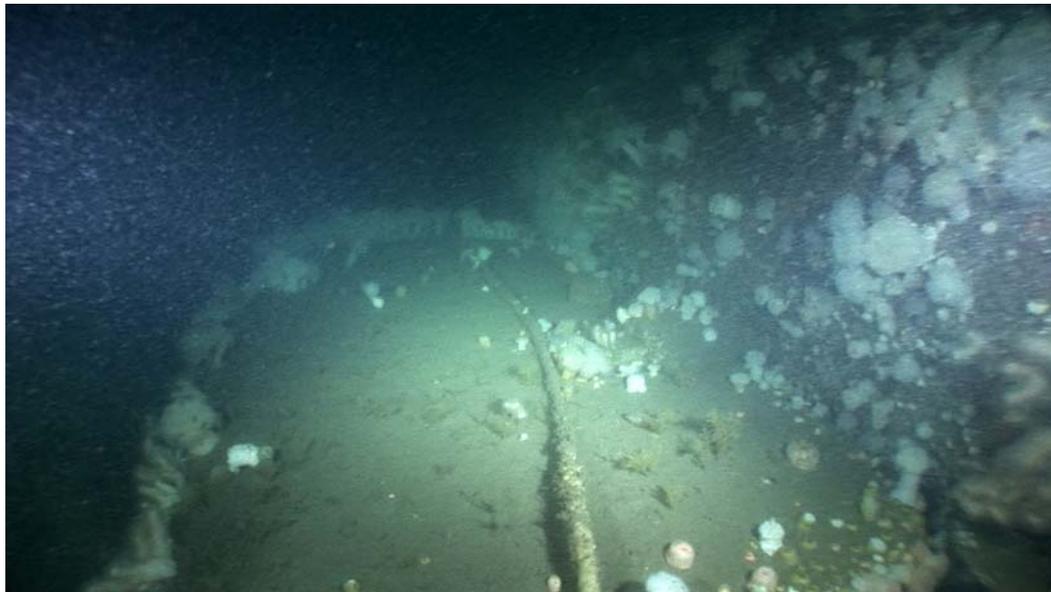
2.3. The view above is of the starboard aft hydroplane which is shown in a level position. The hydroplane is clear of the seabed.

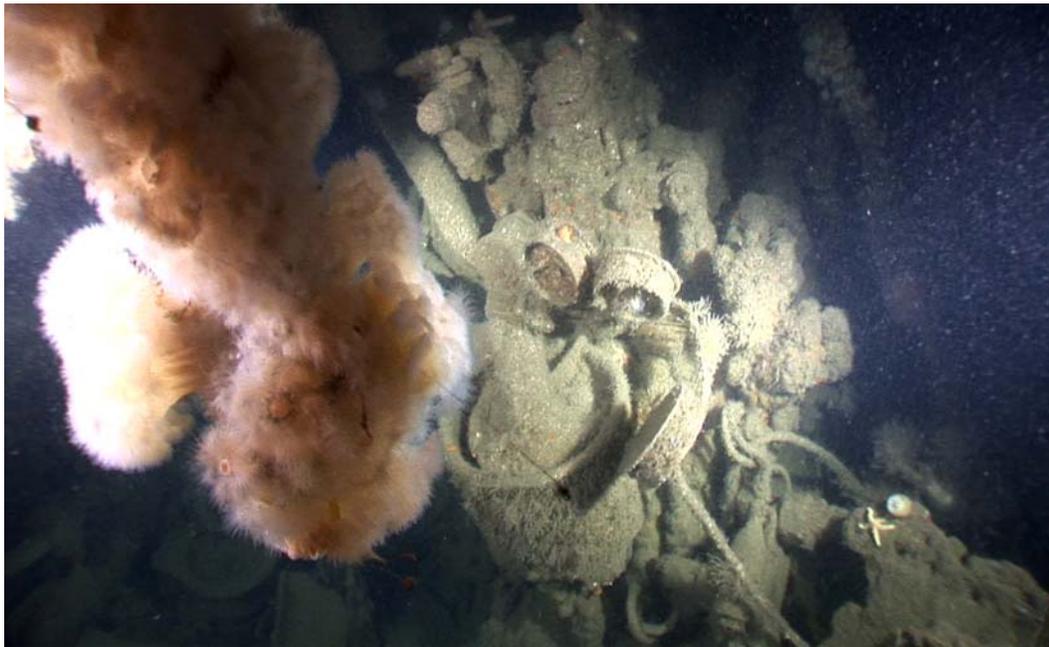
3.1. There is a split in the pressure hull and double skin above at a point on the starboard side just forward of the aft hydroplane. The location of this can be precisely given by reference to the machinery that can be seen within. Above you can see the aft end of the oil engine along with its pressure gauges. Also in the bottom left hand corner it is possible to make out one of the ships toilet. It was reported by other team members that a second toilet was positioned next to this one.

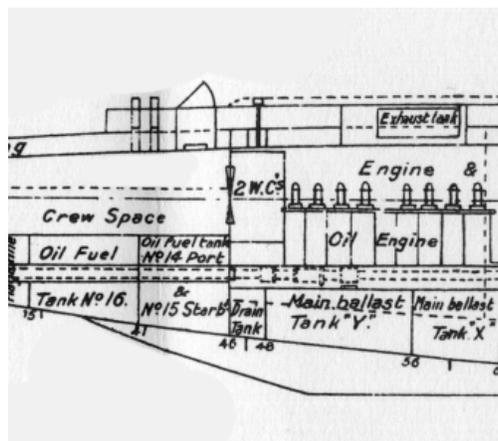
3.2. From the sectional elevation drawing it is possible to see that there are two toilets adjacent to the aft end of the Oil Engine.

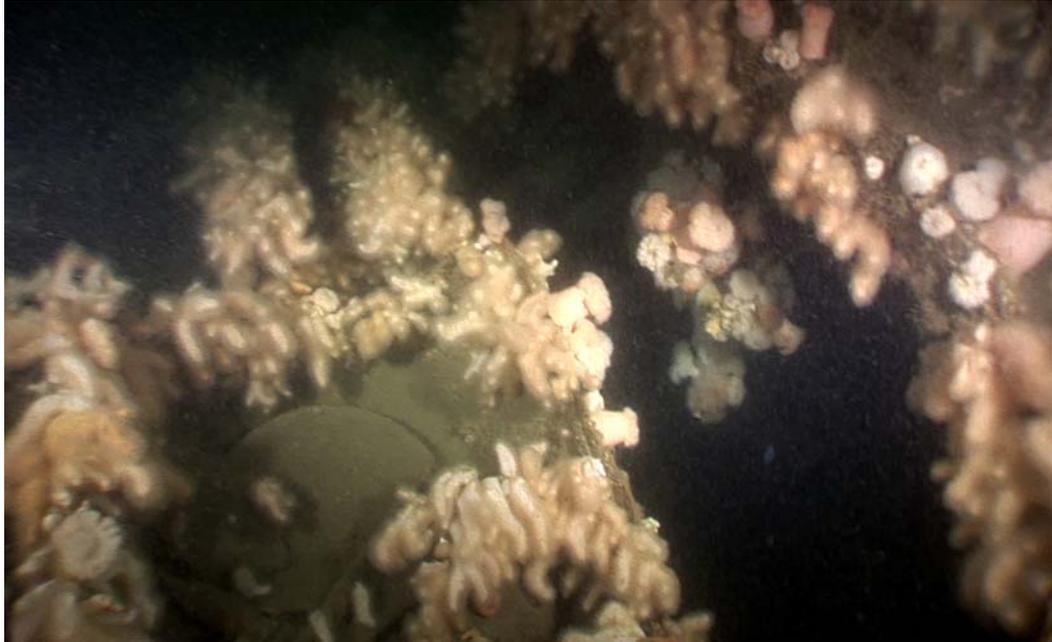
- 3.3. The still above shows the split in the hull viewed from above the deck. The closed hatch is the aft escape hatch which was positioned along the centre line of the hull. This indicates that the “V” shaped split extends to a point well beyond the centre of the hull. The split comes in from the starboard side (i.e. bottom right of picture)

- 9.2. For this to have occurred it is likely that the aft end flooded first which suggests that the split in the hull at the rear of the engine room was the reason for the sinking and the first area of damage.

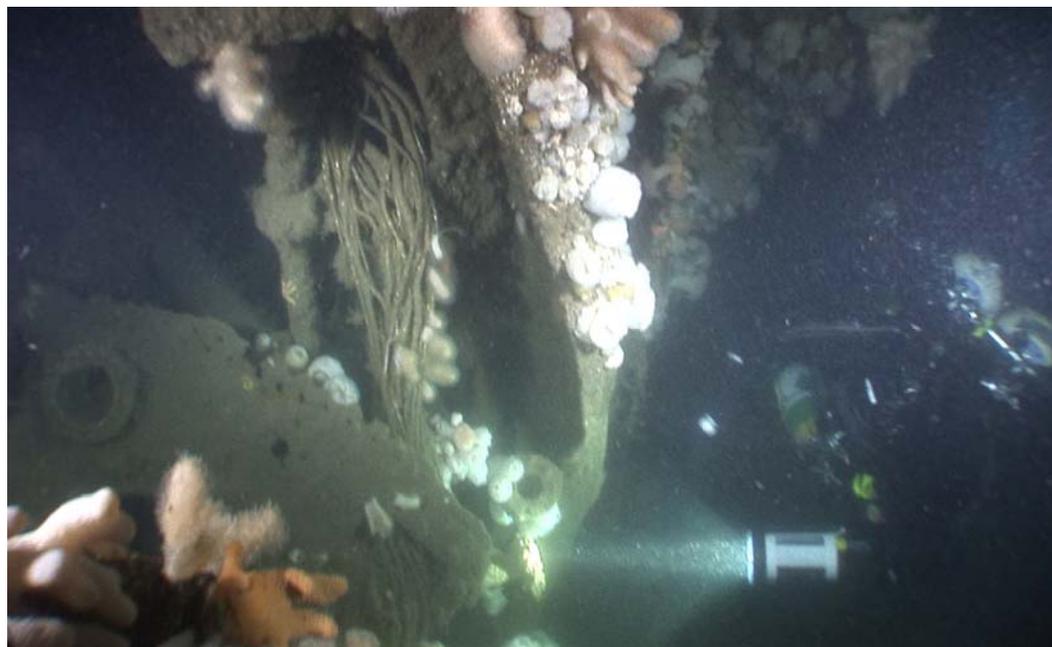
- 3.4. The still above shows the starboard side of the hull at the position of the split. The split is widest at deck level and tapers down to a point below.

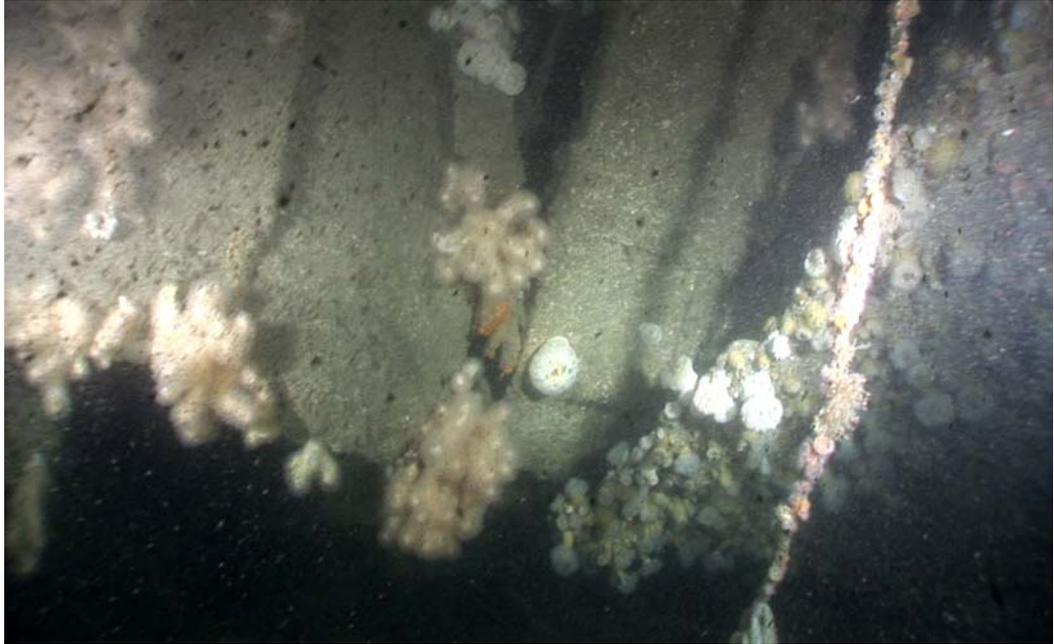
- 3.5. The view above shows the lowest point of the hull and the “V” shaped split. The split extends to a point almost level with bottom of the pressure hull. The hull at this point is clear of the seabed.

- 9.3. The split at the stern is wide at the deck and comes to a point at the bottom of the hull. The damage is clearly consistent with a collision from the starboard side and furthermore it is consistent with a collision from a vessel of a similar draught. Had a vessel with a deeper keel been responsible for this damage I would have expected to see less of a vertical "V" shape to the split and more damage to the underside of the pressure hull. In my opinion this makes it much more likely that this is the wreck of K4 and that the damage sustained was caused by K6, a vessel of a similar draught.

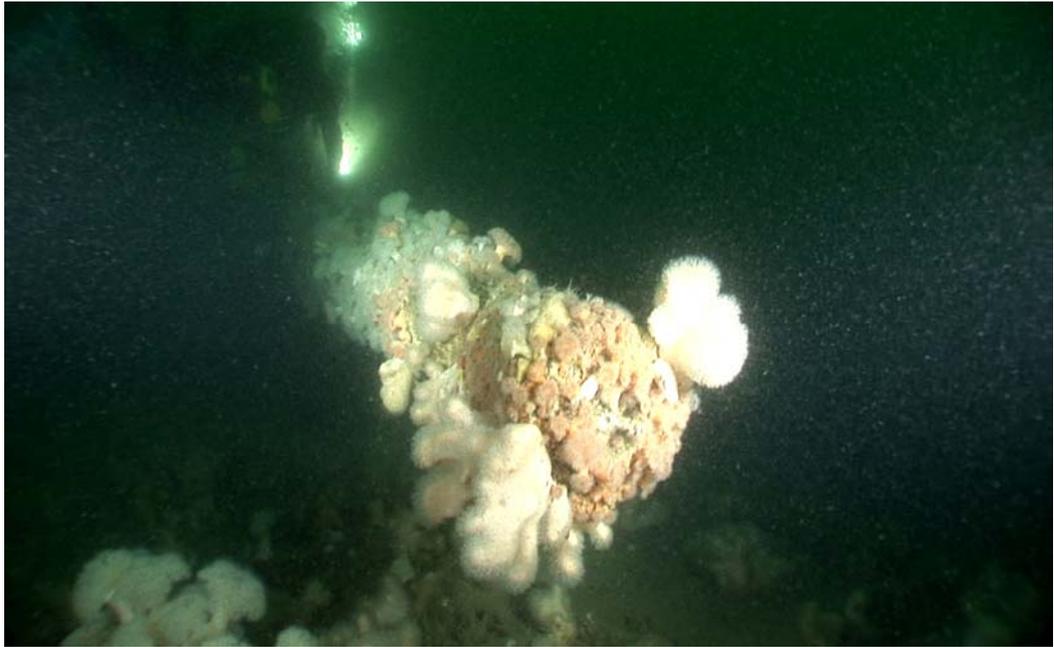
4.1. The deck gun is sat with its barrel parallel to the deck and in line with the centre line of the hull. The gun barrel is pointing forwards and has an end cap in the barrel.

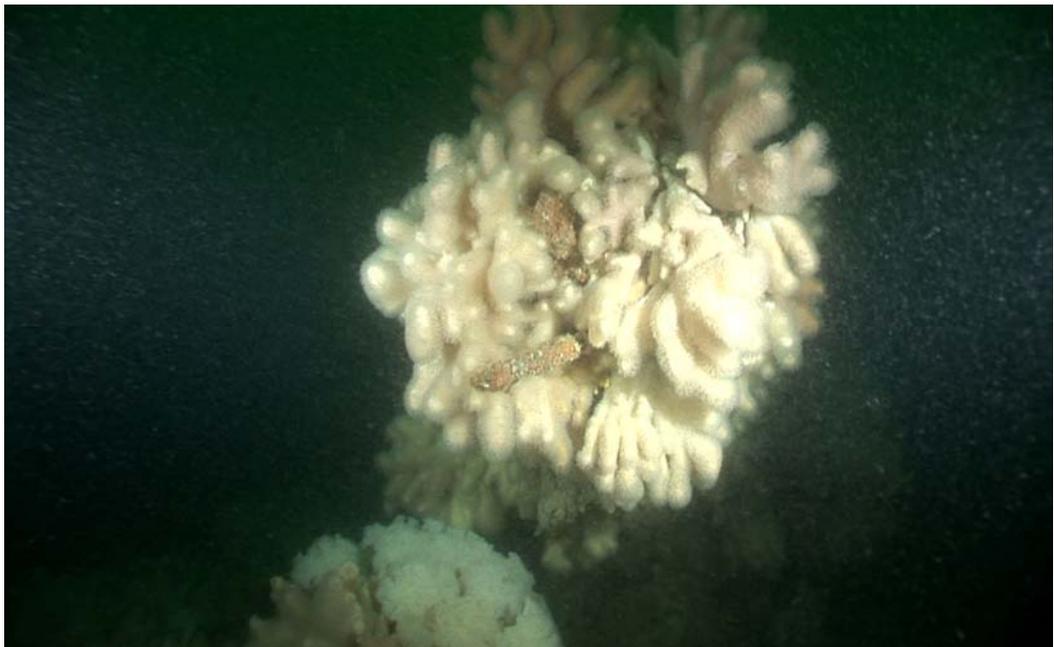
4.2. The breech end of the gun is completely obscured by anemones and it is very difficult to make out any detail.

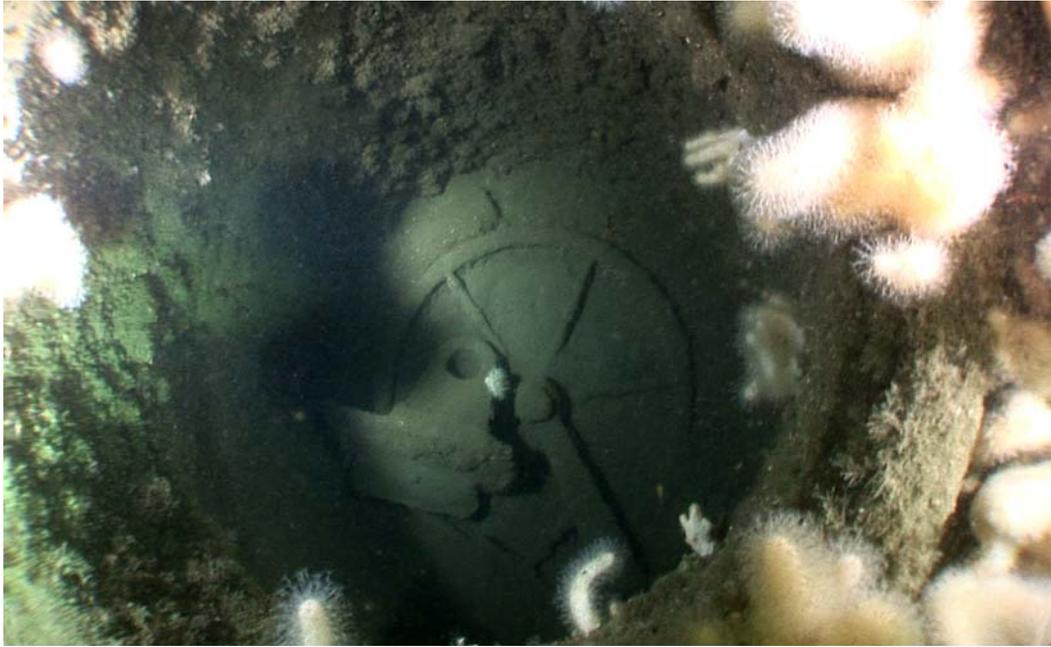
- 5.1. The image above is of the inside of the aft funnel casing. The outer hatch is fully open and laid back hinged on the forward edge of the opening. The bottom right hand corner of the photo is the forward side of the casing. The hatch seen at the bottom of the casing is thought to be an inner hatch and a piece of debris has fallen in on top of it.

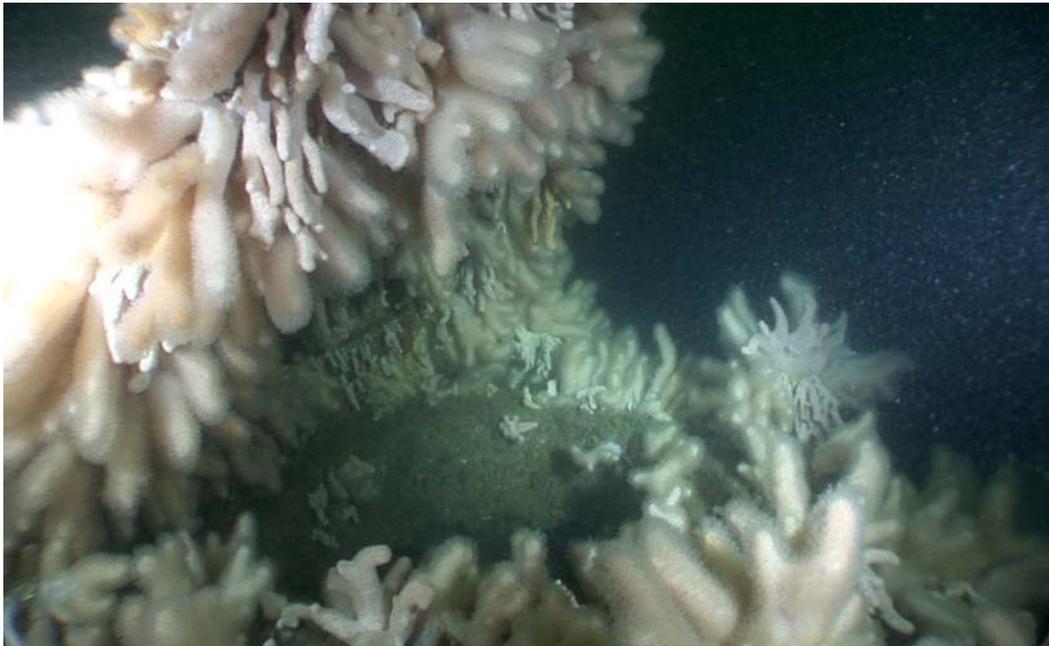
- 5.2. The view above shows the forward funnel hatch, this hatch is hinged on its aft edge and is nearly closed. No indication of the funnel was seen.

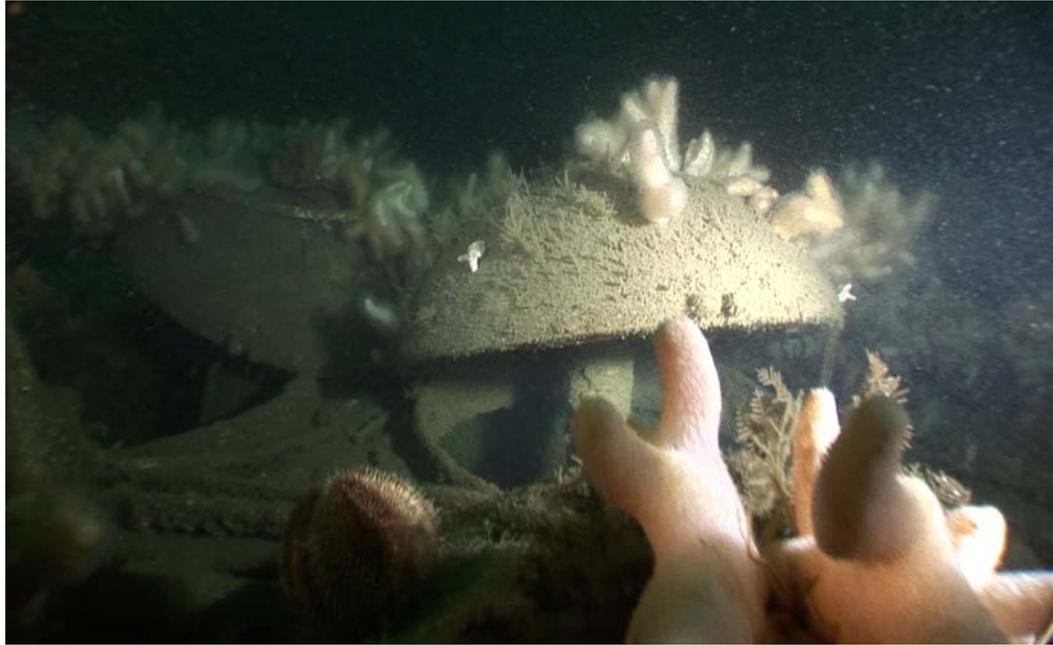
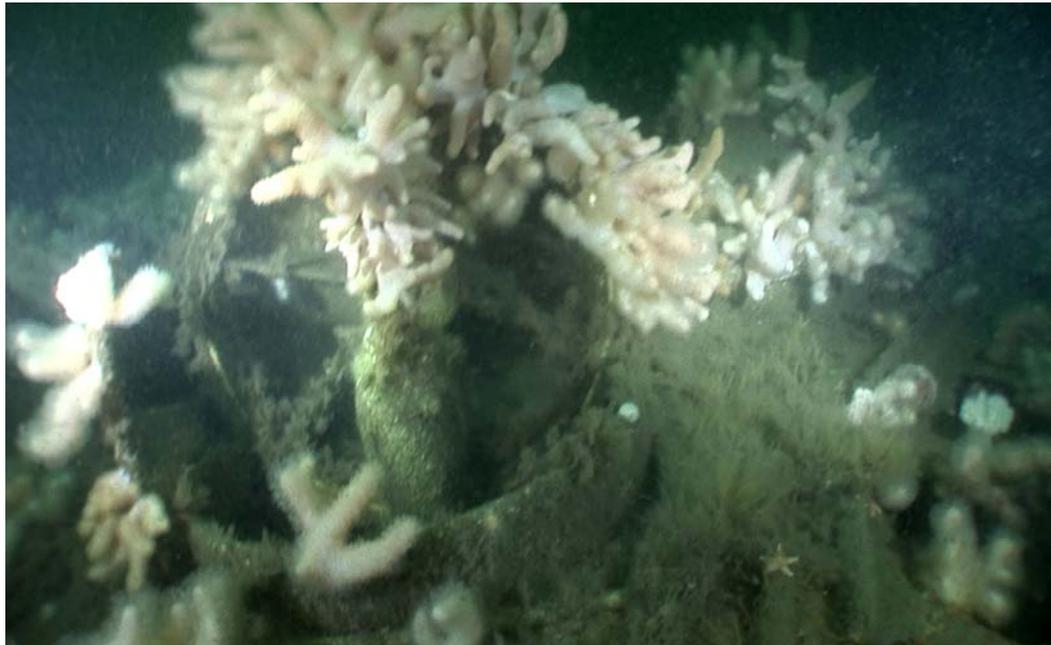
5.3. Between the two funnel casings there are a group of six air vents with semi spherical bronze hatches. They are all open to some degree. The aft end of the wreck is to the right of the picture and the vents shown are the two most aft on the port side. Below the picture shows the forward vent on the port side. Its bottom edge is in a vertical alignment and is therefore either fully open or broken off.

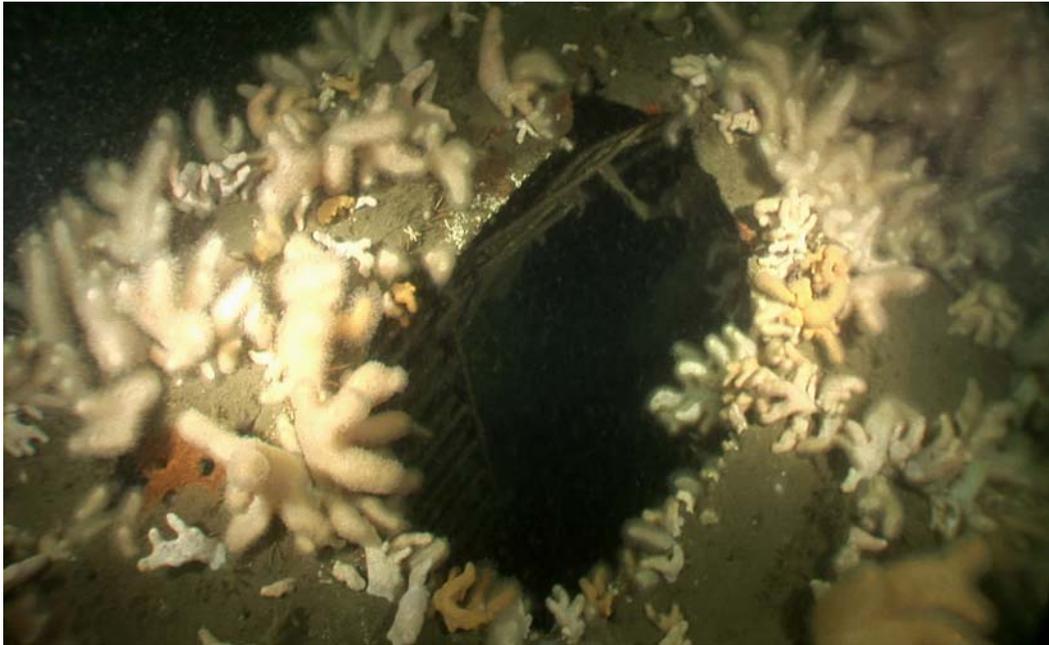
- 6.1. The conning tower and deck house are not in position on the hull. There is a large hole where the conning tower should be and through this it is possible to view the control room beneath. The pressure hull casing around where the conning tower was positioned shows no sign of explosion or impact damage, removal of the conning tower has caused only slight bending and buckling of the main hull.

- 10.3. We would like to conduct a swim line search for the bow section of the wreck and I would like to film this for completeness.
- 10.4. I intend to take some close up footage of the flange at the base of the conning tower and the corresponding hull above the control room. It would also be very useful to find a rivet from this joint for inspection.

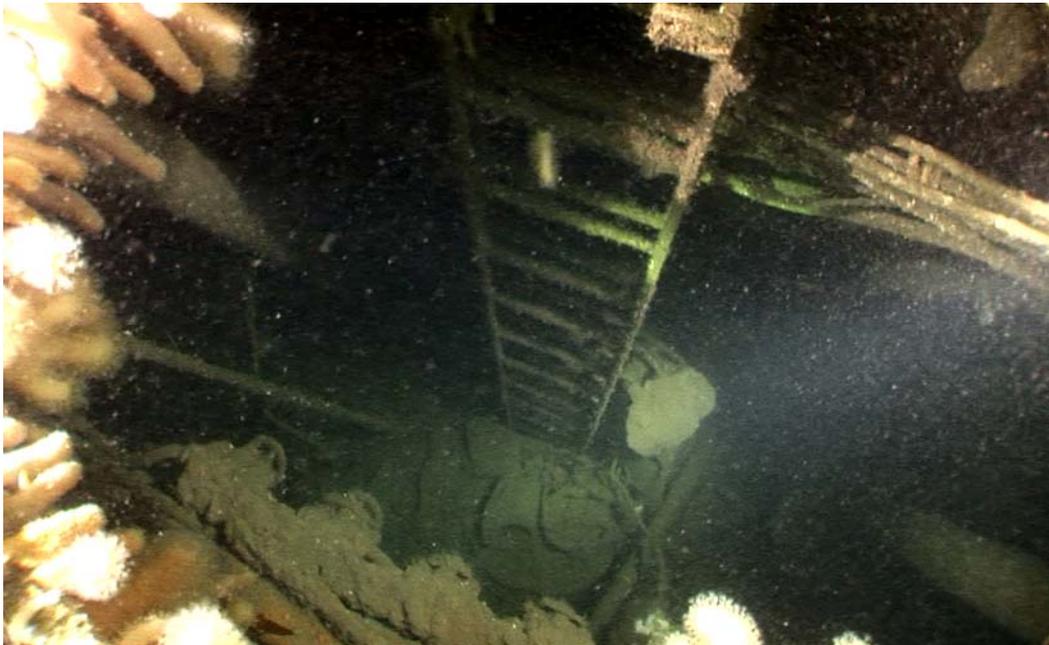
- 6.2. Both the forward and aft periscopes can be seen in the control room, seen here at 10 O'clock and 4 O'clock but they do not project above the hull casing. The ladder is on the port side of the opening.

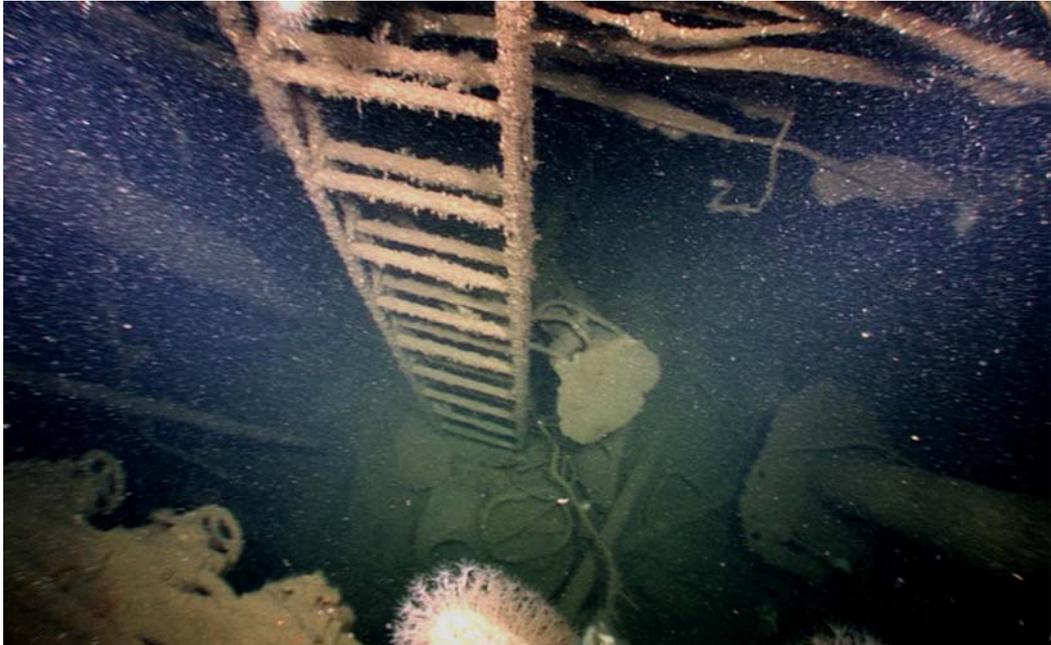
6.3. Silt levels in the control room are very low as debris can be seen on the floor of the control room. The size of the hole into the control room is large enough for divers to enter the wreck. This would clearly be extremely dangerous but if anyone was so minded it would be possible.

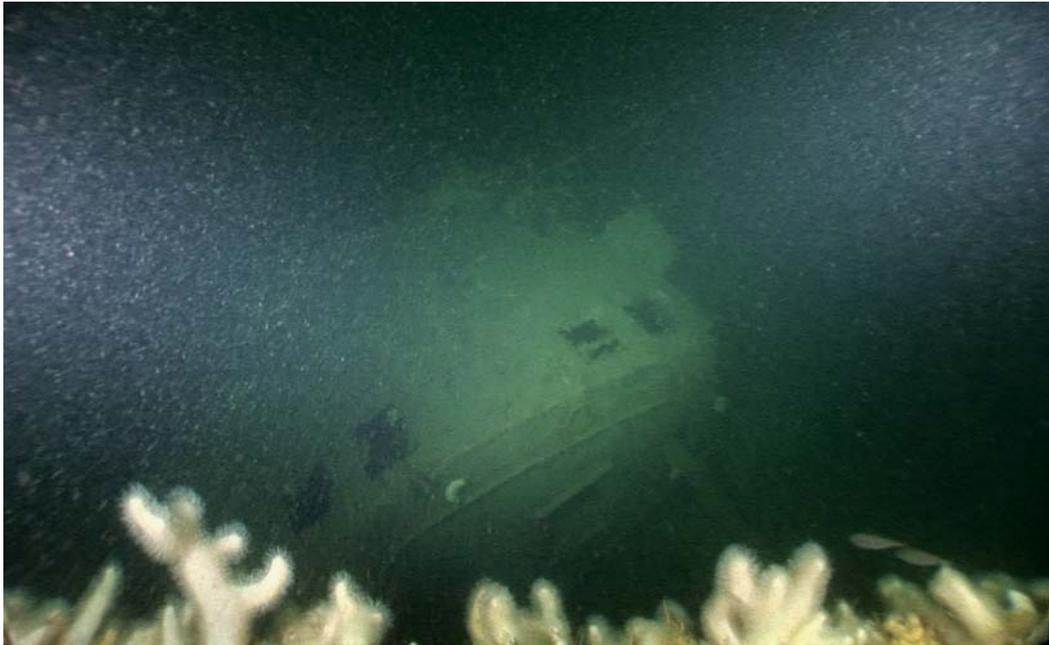
- 7.1. The deck house is laid on the seabed to the starboard side of the control room opening. The deckhouse is laid on its port side with the top of the deck house closest to the main hull. The base of the deck house shows signs of damage but without significant distortion and the rear end of the deck house, where the last window and door would be, is missing.

- 9.8. The orientation of the deck house, i.e. the roof facing the main wreck, suggests that the two parted company before they hit the seabed as the deckhouse would need some time to flip over into this orientation. Had the deck house just fallen off the wreck or had it been trawled off the wreck it would still have retained some attachments along its bottom edge and would have had the roof furthest away from the main hull. This would have been more typical of conning tower damage and positioning.

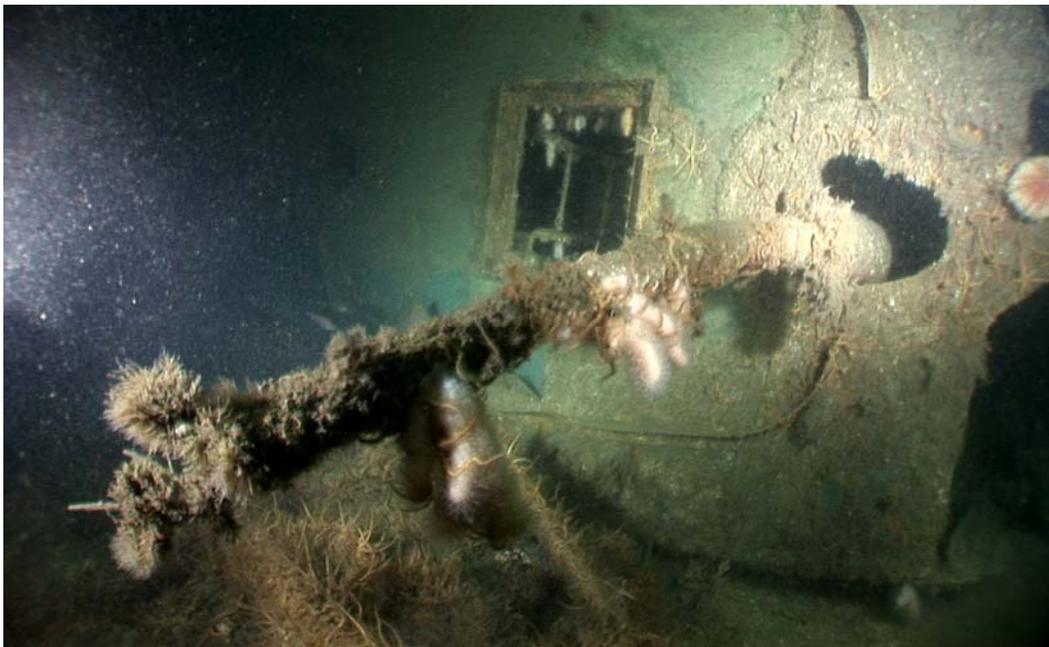
- 7.2. The aft periscope top is still in position through the deckhouse roof. The forward periscope top is laid on the seabed unattached.

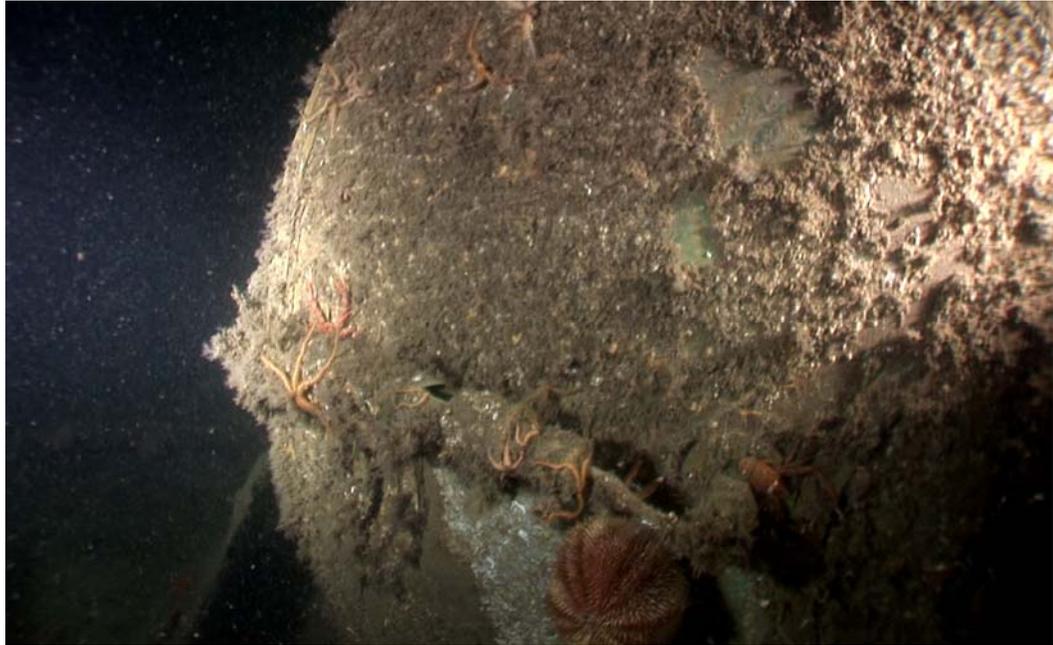
7.3. The steam whistle is still in position on the front of the deckhouse roof.

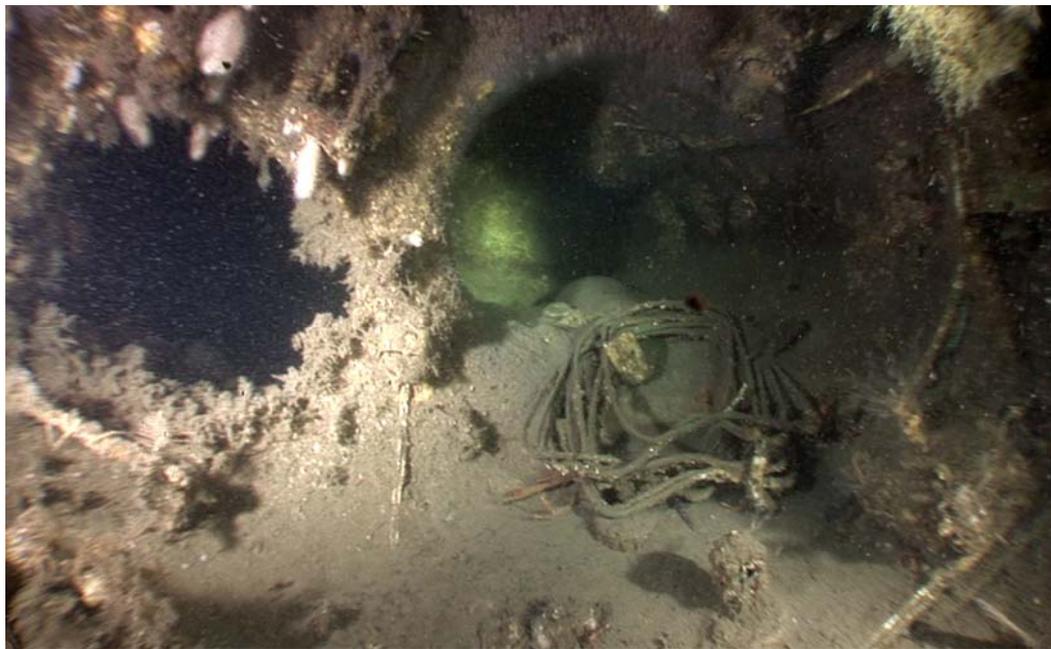
7.4. The inside of the conning tower can be seen from the underside of the deckhouse.

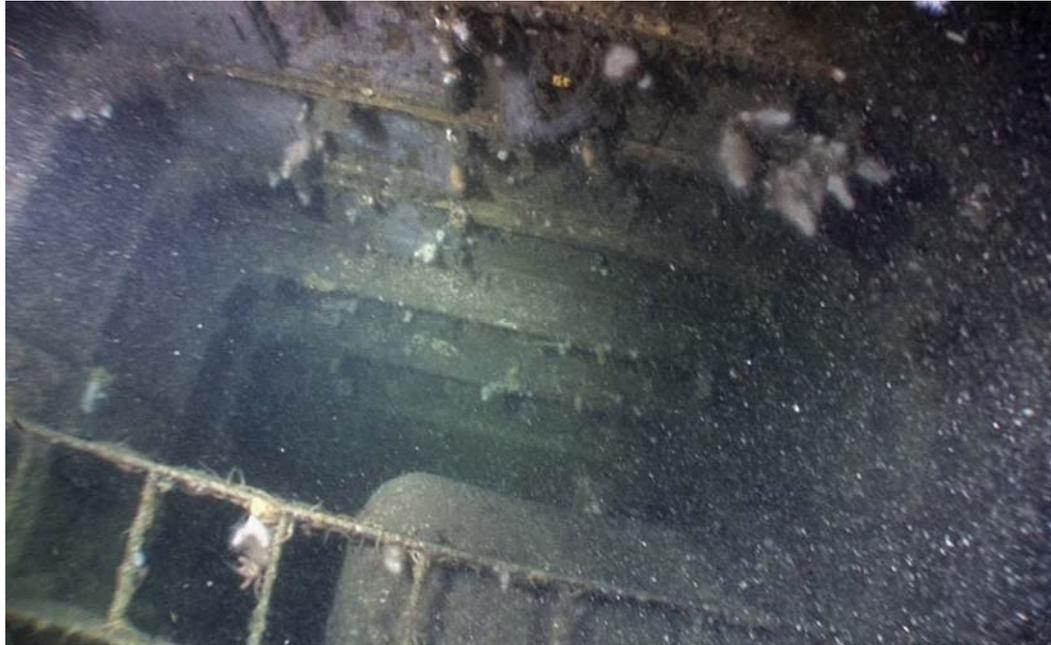
7.5. The outside of the conning tower can be seen behind the ladder, through the damaged area at the rear of the deck house. The ladder gives access from the deckhouse to the deckhouse roof.

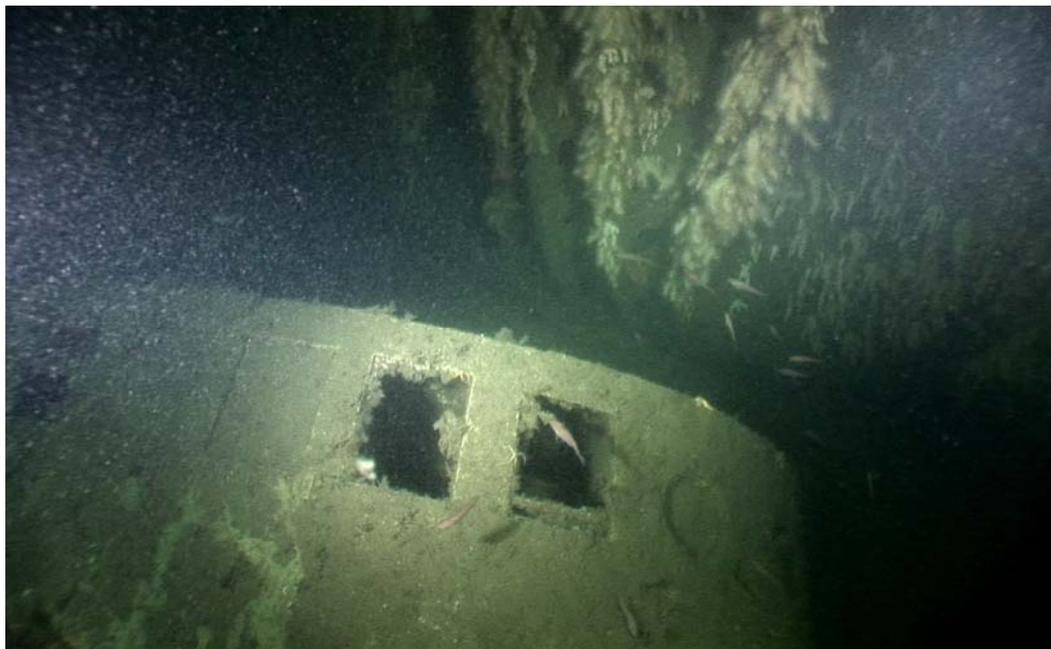
7.6. The deck house roof is within 2 metres of the main wreck, the main hull at this point is not sunk into the seabed.

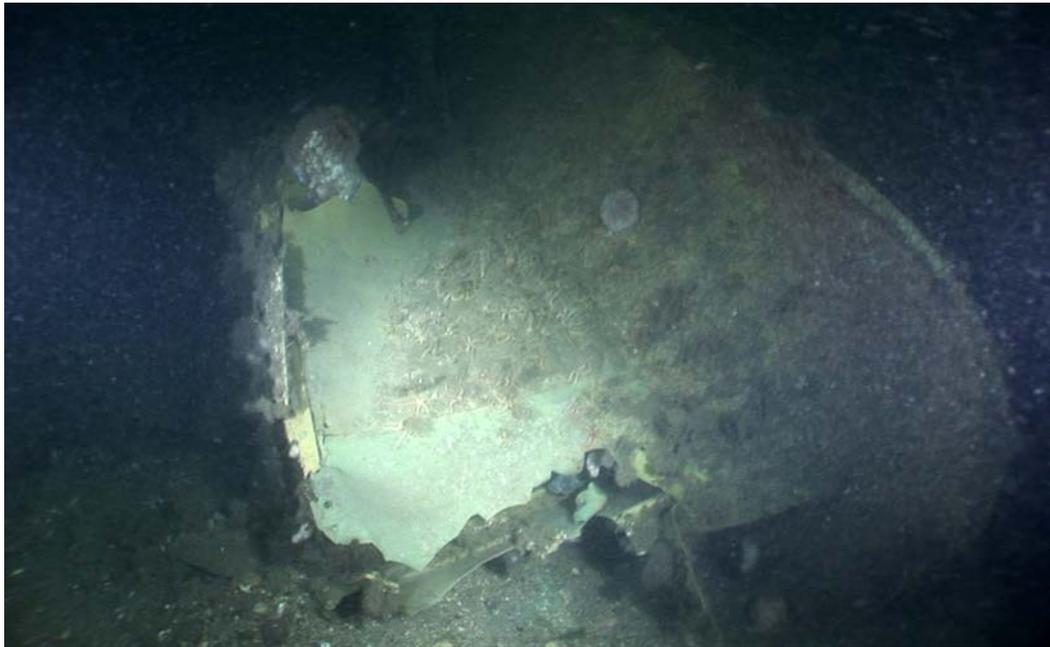
7.7. This view shows the front of the deck house and the streamlined fairing at deck level.

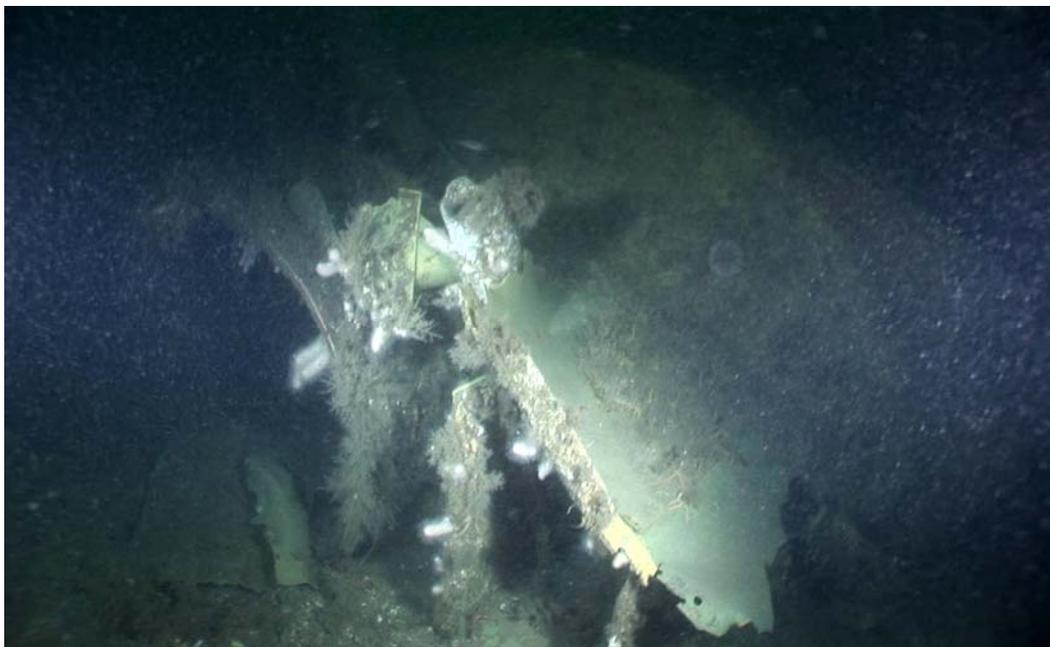
7.8. This view shows the same fairing as 7.7 but the clean lines of the base of the conning tower are also visible.

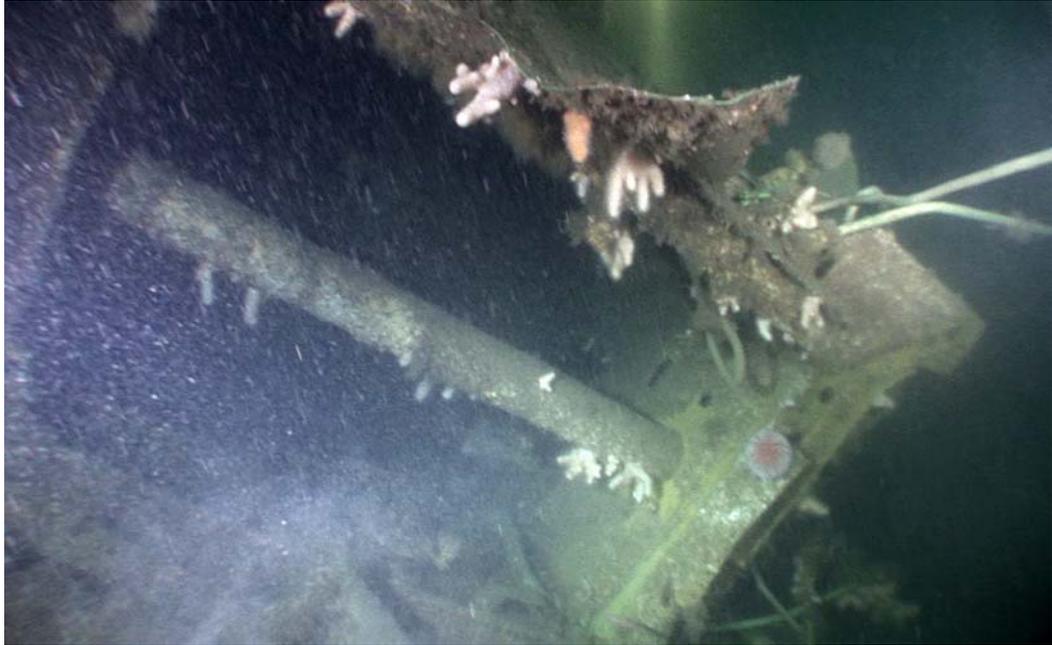
7.9. This view shows the damage at the back of the deckhouse. The aft periscope can be seen still fixed into the deck house at floor and roof level. The rear end of the deck house where the door was positioned is entirely removed (see elevation in 8.3) however the deck house shape is largely retained and is not distorted. The deckhouse and conning tower are made of brass and bronze respectively.

buckling or bending of the deck, and without significant distortion of the bottom edge of the conning tower or deck house. The periscopes seem to have sheared off cleanly at deck level. The aft part of the deckhouse is missing but it has parted company along a frame and this is also a relatively neat severance from the whole (there is some brass sheet torn along the starboard edge and bent backwards in 7.9).

- 9.9. The missing aft section of the deckhouse may well be due to a lighter form of construction that did not stand up well to the sinking process. The door area would have introduced a weakness in this area.

- 10.5. There is further debris on the starboard side aft of the deckhouse and this maybe the missing part of the deck house. I would like to film this area.

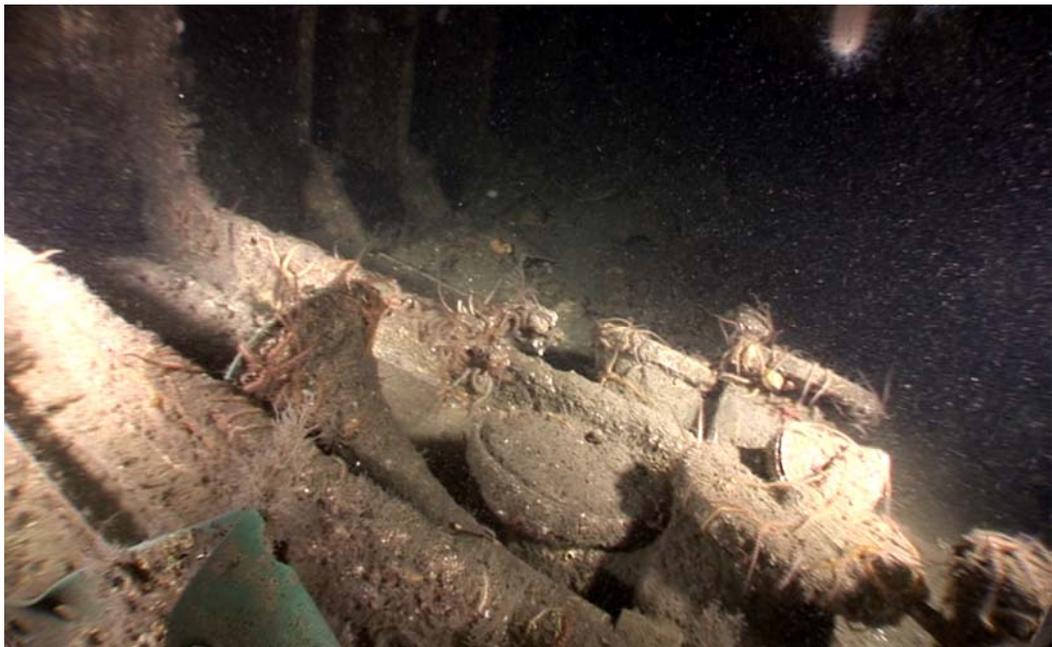
7.10. This picture shows artefacts in the deckhouse.

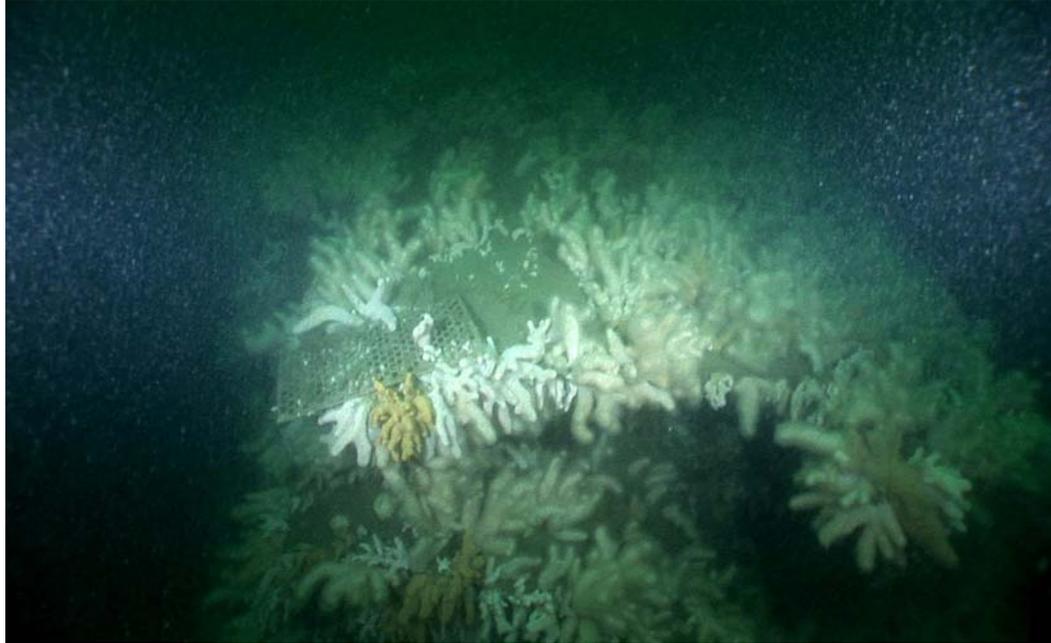
- 8.1. The forward section of the hull is missing. The break has taken place somewhere close to the forward end of the keel. This view shows the break from deck level, there were no signs of the forward deck gun or mast.

- 9.4. The damage at the bow follows the line of a frame and most likely occurred on the surface. If the hull had parted anywhere else the two parts would be very close together on the seabed. A search for the missing bow was made during the dives but it was not found within visible range of the main hull.

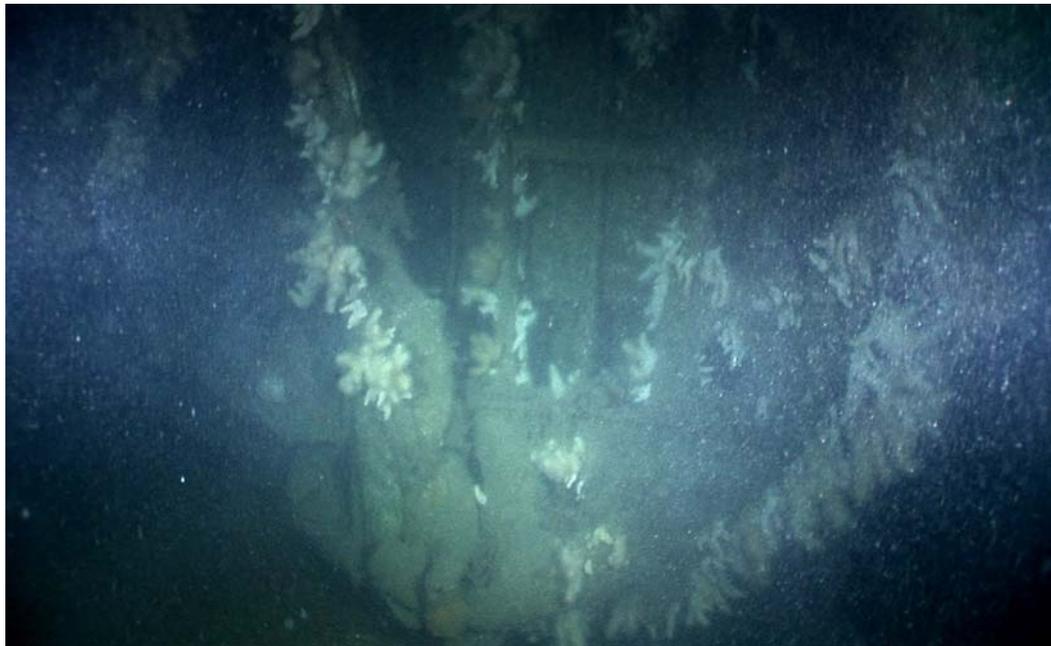
- 8.2. The hull at this point is sat above the seabed and is most likely supported on the keel. A below floor bulkhead is visible in the centre of the picture, it is set back from the split by about a metre.
