Dive Report

K Class Submarine

Firth of Forth
June 2007

Written by Andrew Jackson BSc CEng M.I.C.E.

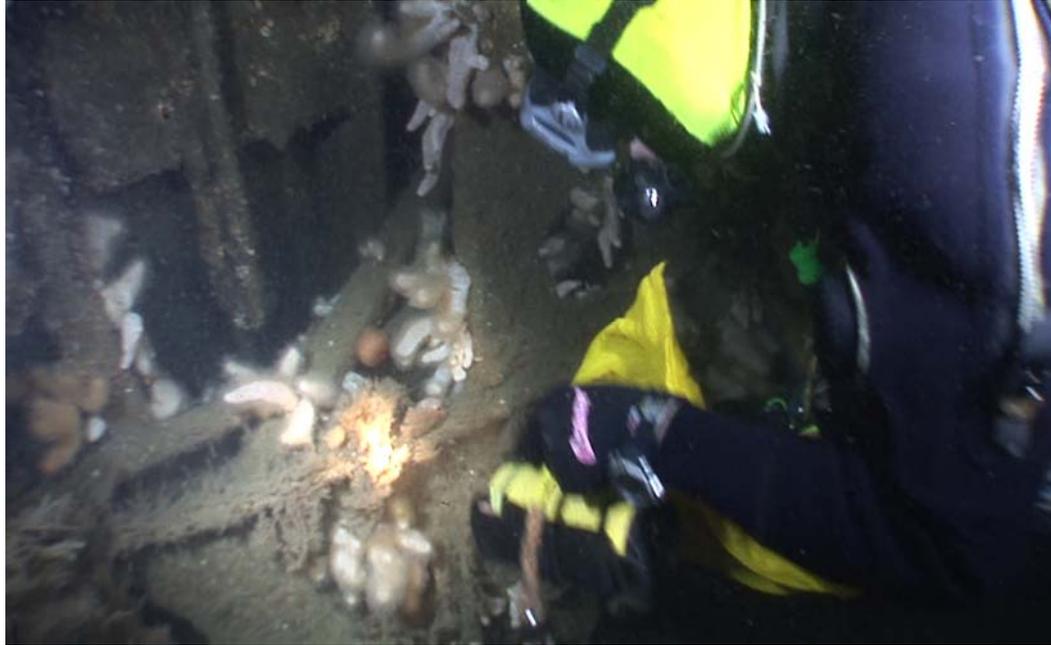
8.3. This is a closer view of the bulkhead and structural frame in foreground. The break in the hull is coincidental with this frame. The break is quite clean on the port side but more uneven and ragged on the starboard side.

- 10.6. I would like to take a closer look at the starboard side of the forward end of the main hull in order to understand why this break is not as clean as the break in the hull on the port side.

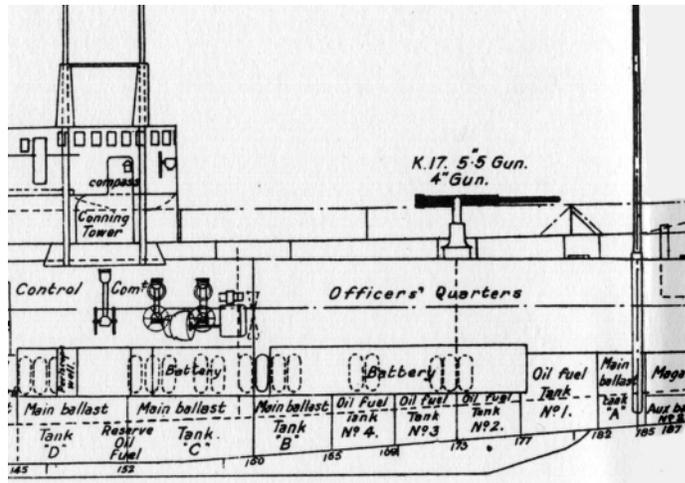
8.4. The sectional side elevation above shows the relative positions of Oil fuel tank No1, Main ballast tank A, the mast, the keel and the Magazine.

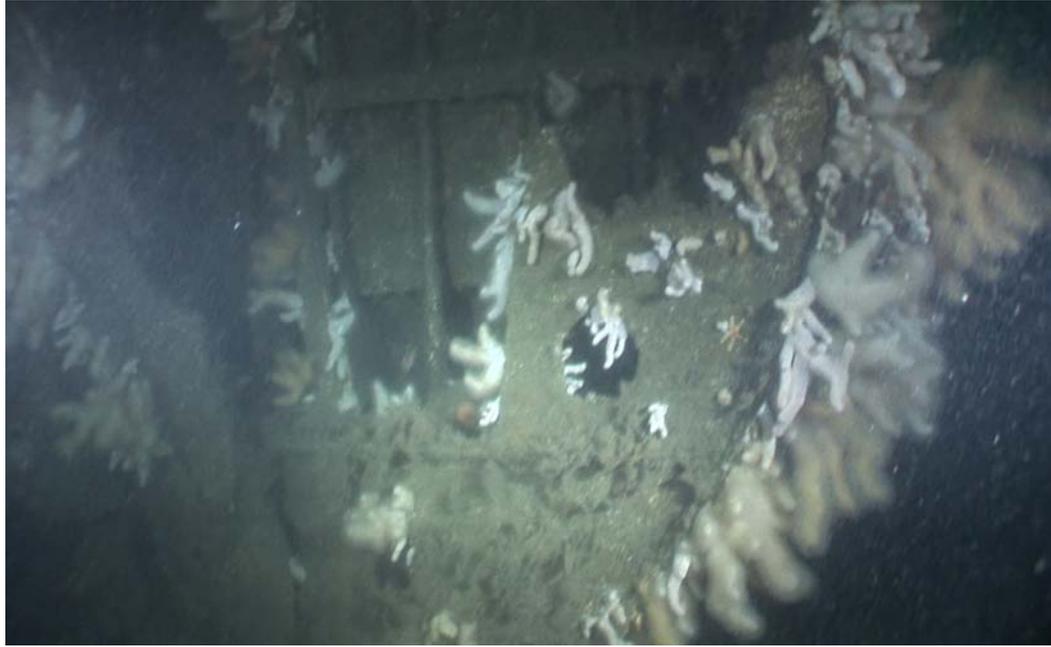
8.5. This view shows a section of plating on the port side level with the break.

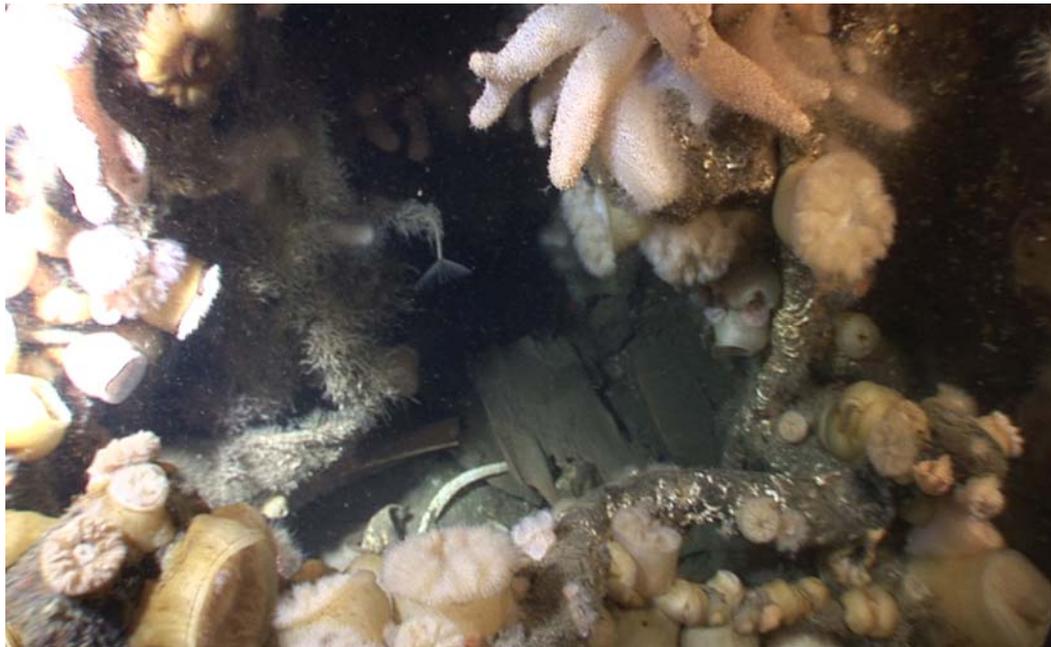
8.6. This view is showing a white curved object which resembles a human rib bone. The timber planks are the remains of the flooring of the officers quarters. At this level it was possible to shine a powerful pencil beam torch aft from the break in the hull and see the hydroplane and steering pedestals in the far distance in the control room.

- 9.14. The white curved object seen in 8.6 appears to be a rib bone. The object close to it was described by one of the team as part of a shoe. Other members of the team reported that there were several rib like objects close together. The presence of human remains is also consistent with the loss of K4 as K4 went down with all hands whilst the crew of K17 managed to abandon their vessel.
